From: Jerry Roseman <jeralia@icloud.com>
Date: October 4, 2019 at 2:44:08 PM EDT
To: "Joseph, Brian" <bjoseph@philasd.org>, "Bonewicz, Paul" <pbonewicz@philasd.org>
Cc: jim <jim@creedonmgt.com>, Arthur Steinberg <asteinberg@pfthw.org>, Danielle Floyd <dfloyd@philasd.org>
Subject: Re: TM Peirce

The photos below were taken at T.M. Pierce on 09.16.2019 when I was on site for a PFT Chapter meeting. During the meeting staff reported a number of concerns including asbestos and lead. I raised this with you in discussion and then you, me and Jim discussed it a bit at our meeting on September 25th. At that point, I understood that there would be District follow-up including evaluation, asbestos abatement as needed, and attention paid to ongoing lead stabilization problems and issues.

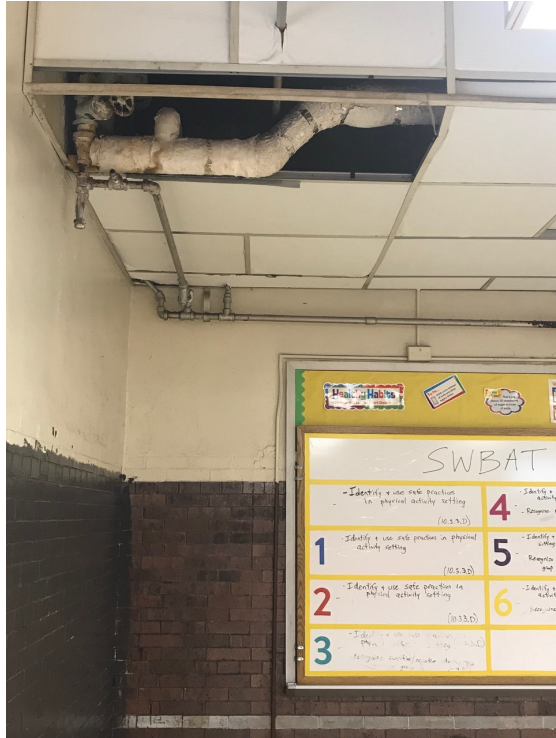
T.M. Peirce - 09.16.2019 - Asbestos insulation in gym - damaged by water leak from above.

I am recommending that we address T.M. Pierce as we have done at Meredith ES - that would include closing the school gym until a full assessment and response effort can be implemented to ensure no remaining asbestos hazard is posed and to also complete a full scale IEQ assessment, and lead-paint/stabilization effort evaluation.

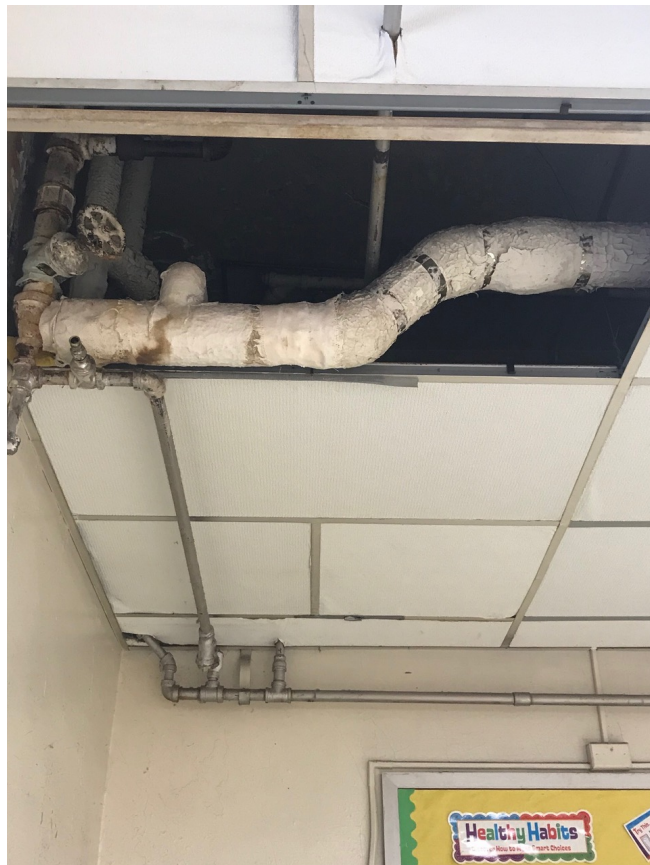
T.M. Peirce - 09.16.2019 - Asbestos insulation in gym - damaged by water leak from above - closer view

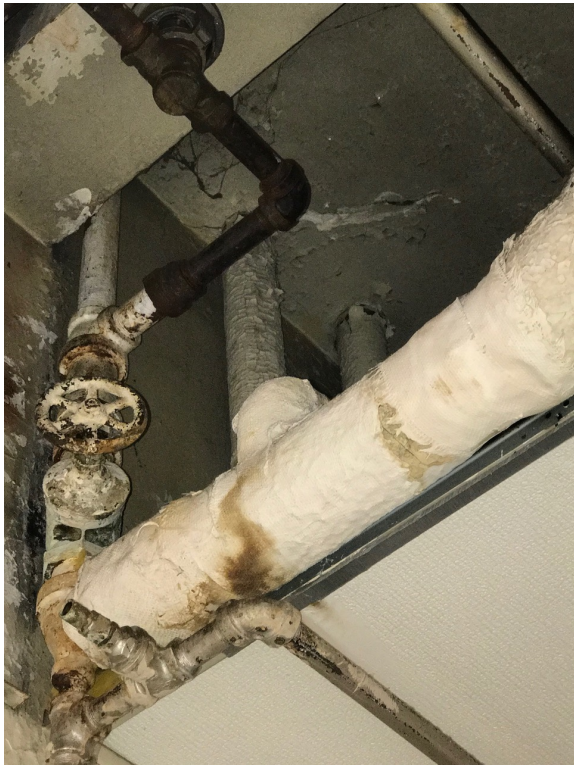
T.M. Peirce - 09.16.2019 - Asbestos insulation in gym - damaged by water leak from above - close look at water impact and repair work conducted

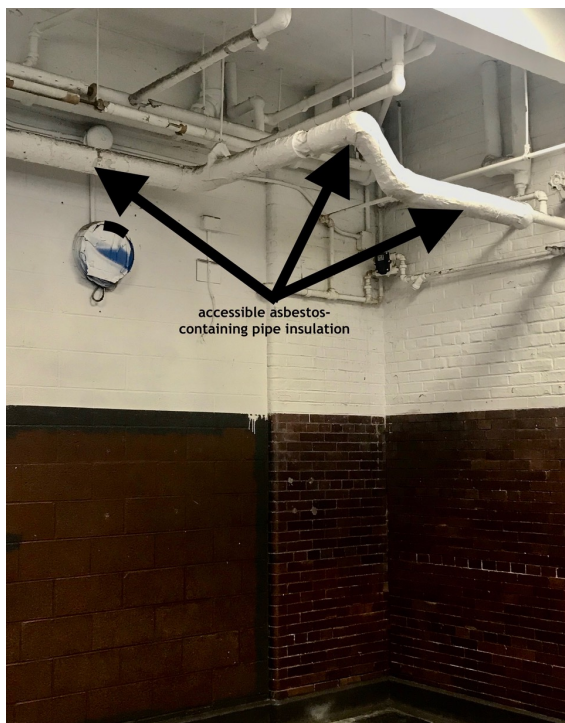
The gym teacher reported that walls, ceilings, and piping is highly accessible to students and easily hit by basketballs and other gym equipment. He reported that he would typically observe dust, debris and paint flakes and chips on surfaces and expressed a concern about the existing conditions.

T.M. Peirce - 09.16.2019 - Accessible asbestos insulation in gym

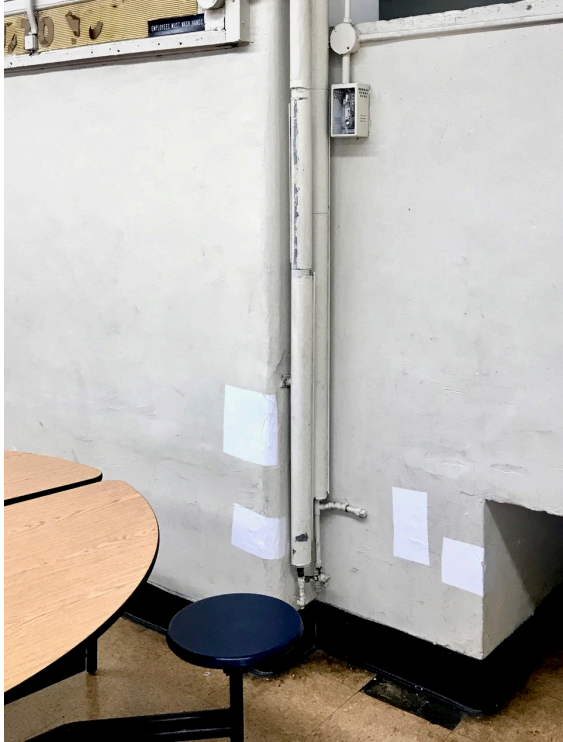
T.M. Peirce - 09.16.2019 - Accessible asbestos pipe insulation in Lunchroom A — bottom of pipe insulation, underneath metal “jacket” is exposed

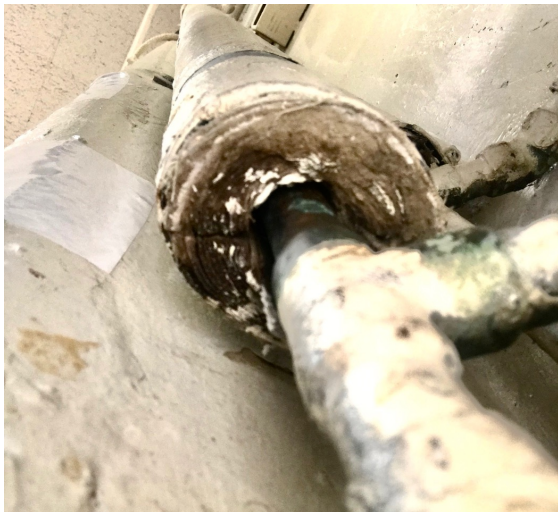
T.M. Peirce - 09.16.2019 - Extreme close-up of bottom of accessible asbestos pipe insulation in Lunchroom A [from picture above]

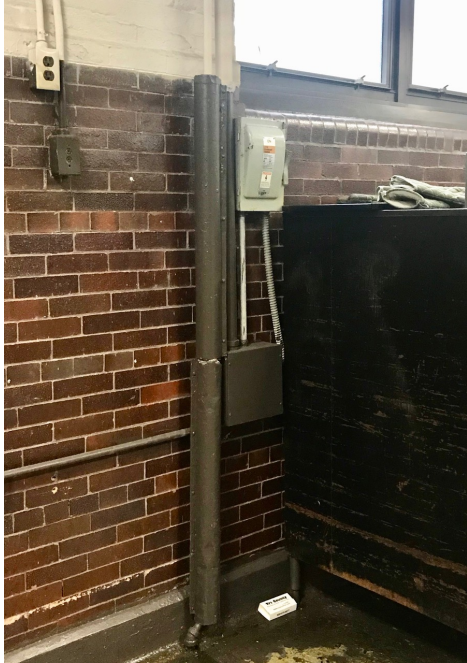
T.M. Peirce - 09.16.2019 - Accessible asbestos pipe insulation in basement hallway — metal “jackets” not properly secured resulting in potential contact damage and exposure

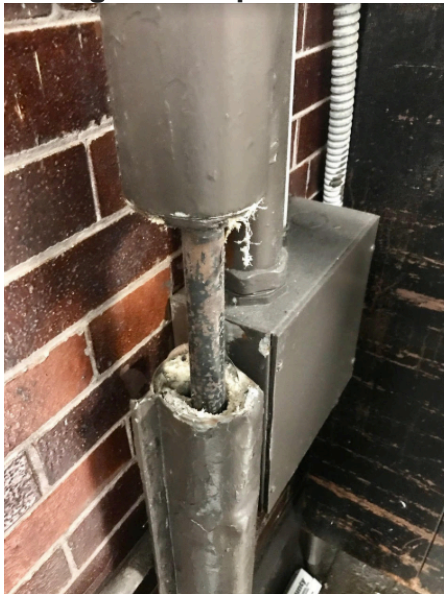
T.M. Peirce - 09.16.2019 - Accessible asbestos pipe insulation in basement hallway — close-up showing metal “jackets” separated [close up of photo below]

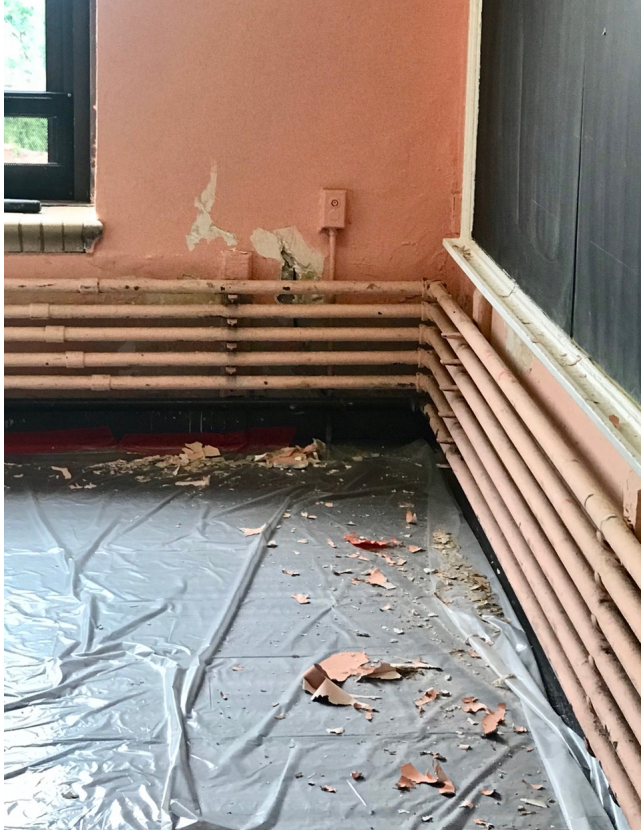
T.M. Peirce - 09.16.2019 - Lead paint work in 3rd floor classroom

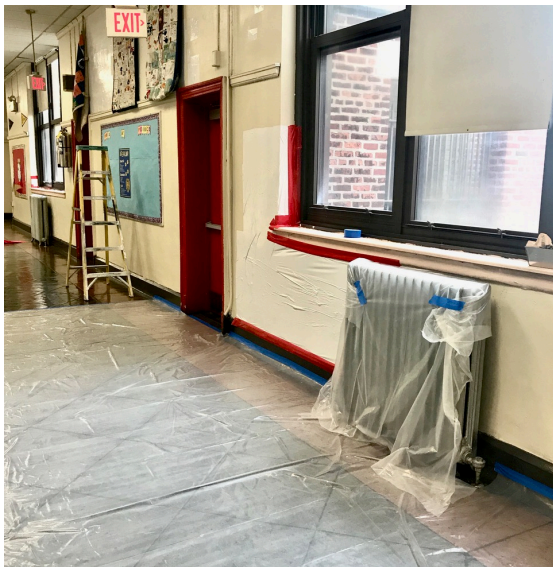
T.M. Peirce - 09.16.2019 - Lead paint work in 3rd floor hallway

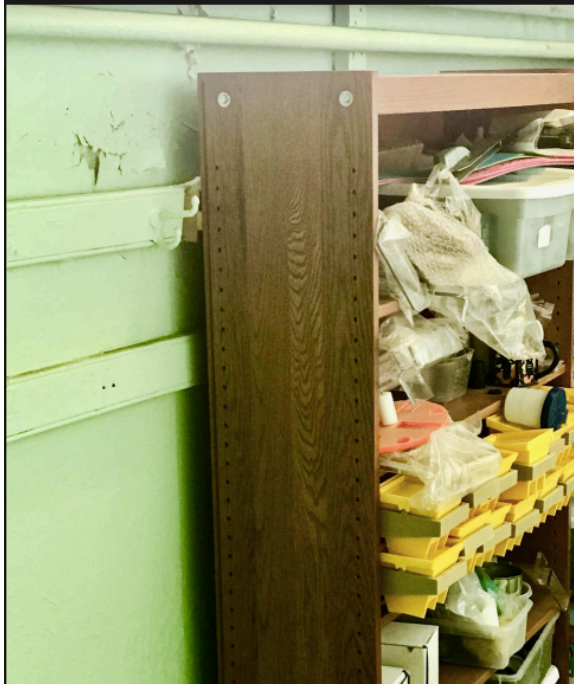
T.M. Peirce - 09.16.2019 -Damaged lead paint work in 3rd floor classroom closet - near supplies

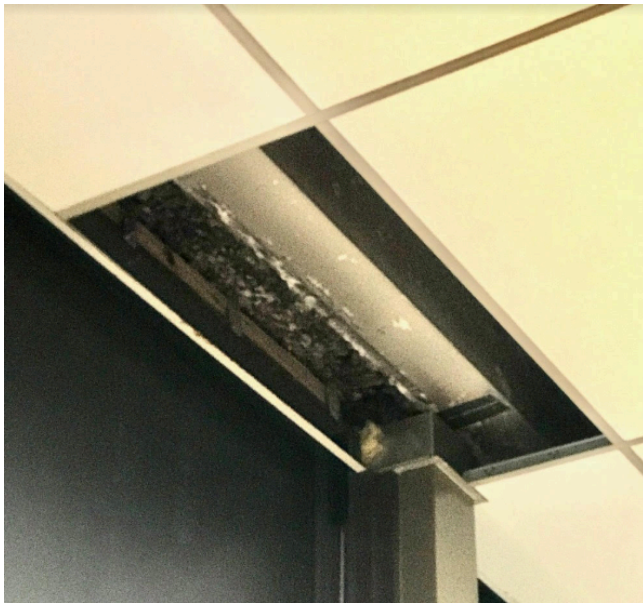
T.M. Peirce - 09.16.2019 - Damaged lead paint in 3rd floor classroom — even above ceilings

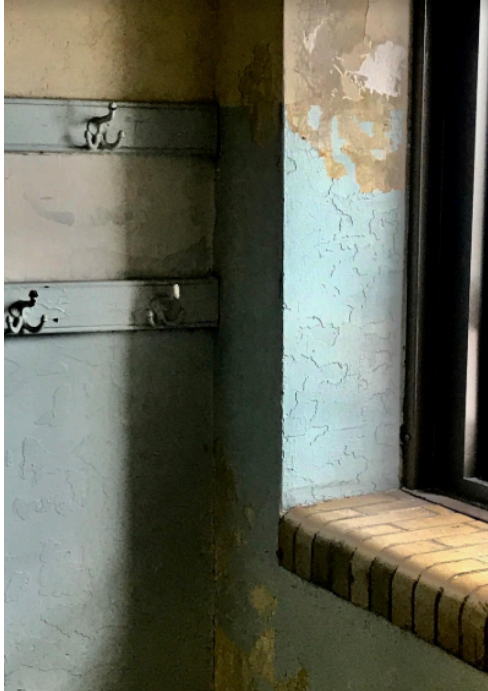
T.M. Peirce - 09.16.2019 - Damaged lead paint in 3rd floor classroom closet

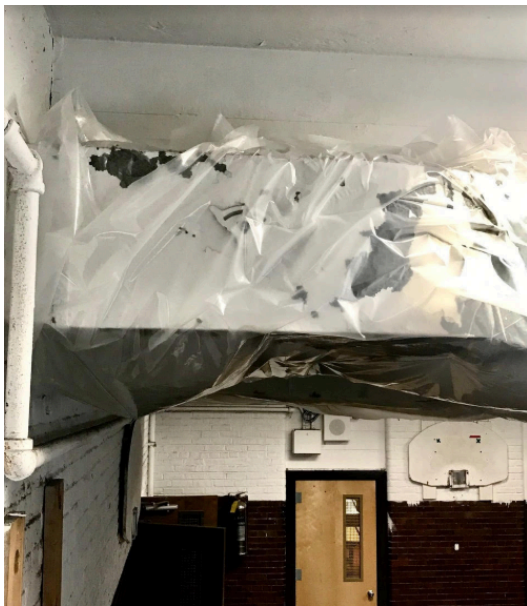
T.M. Peirce - 09.16.2019 - Damaged lead paint on ductwork in gym [covered with plastic as "protection"]
